SERVICE BULLETIN

RM 7211/71/75/91/95, RM 7361/65/71/91/95, RM 7401/05, RM 7501/41/45/51/55, RM 7601/05/51/55, RM 7801/05/51/55

How to handle with broken axes on the MES or AES electronics

Publication-No.: 599 5302-59 en / Service 2007.07.19 BO / KV

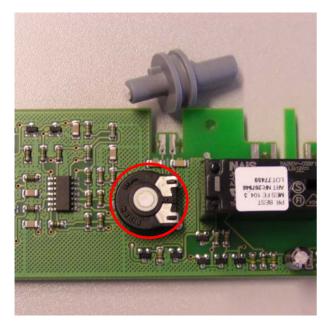
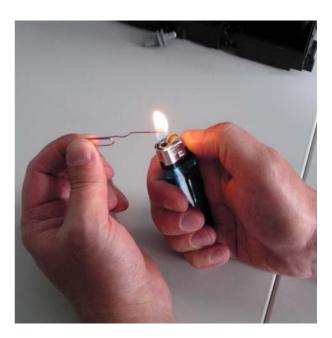
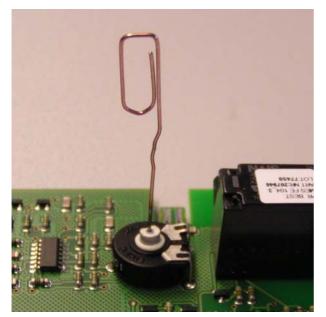
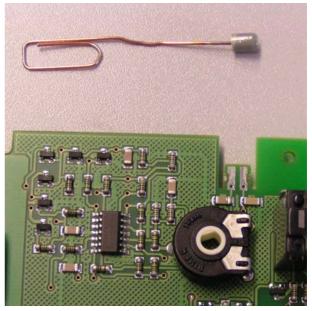
It might happen that the axes of operating knobs on the electronics could break. A broken axis should be replaced by a new axis.

The following pictures show how to remove menaining pieces in the potentiometer.

Exchanging the electronic board is not necessary.
